**DEPARTMENT OF TRANSPORTATION**

Contract #: 04-0120F4Cty: SF/ALA Rte: 80 PM: 13.2/13.9File #: 69.28**WELDING INSPECTION REPORT****Resident Engineer:**Siegenthaler, Peter**Address:** 333 Burma Road**City:** Oakland, CA 94607**Report No:** WIR-018025**Date Inspected:** 10-Nov-2010**Project Name:** SAS Superstructure**OSM Arrival Time:** 700**Prime Contractor:** American Bridge/Fluor Enterprises, a JV**OSM Departure Time:** 1900**Contractor:** Zhenhua Port Machinery Company, Ltd (ZPMC), Changxing Island **Location:** Shanghai, China

**Bridge No:** 34-0006**Summary of Items Observed:**

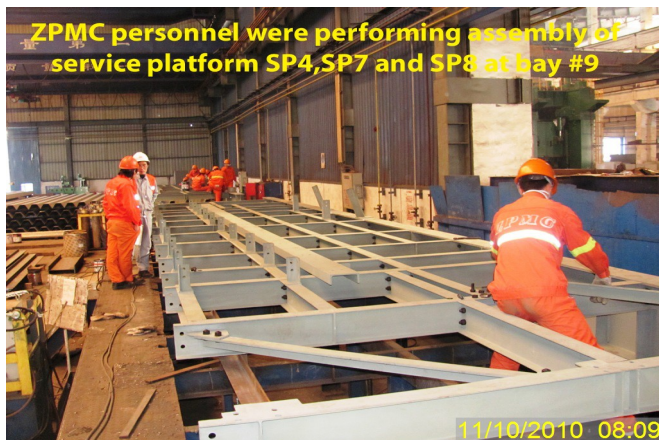
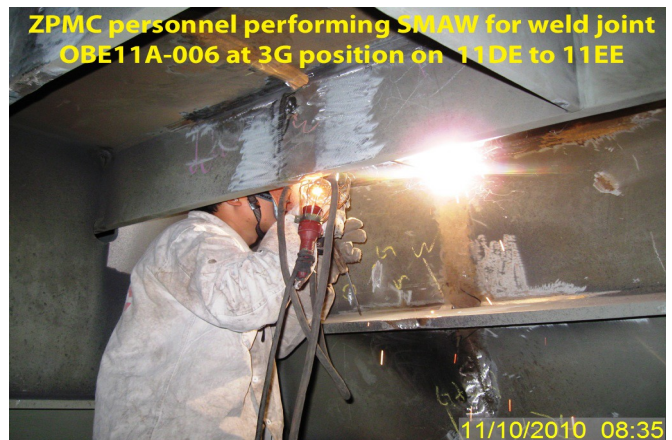
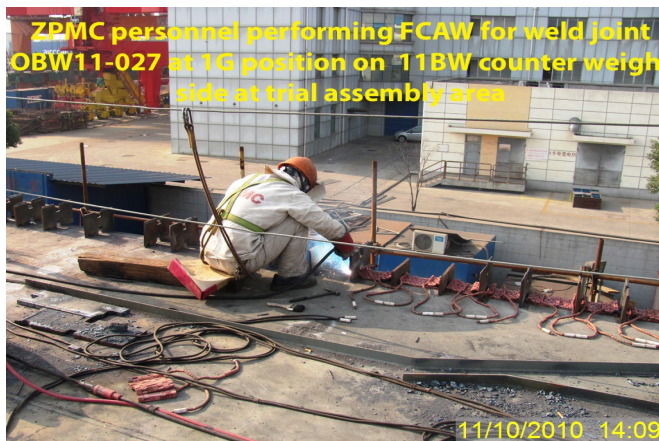
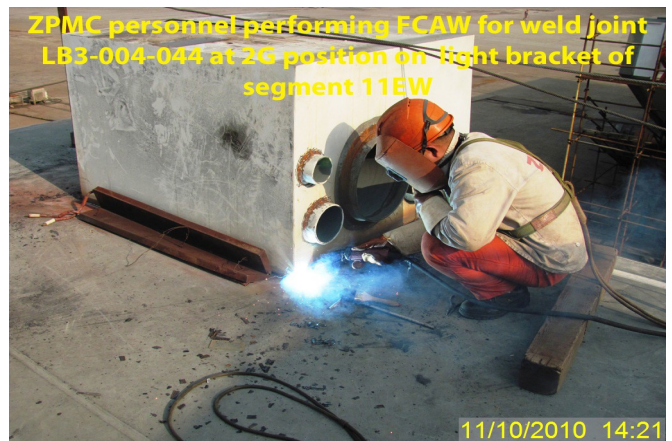
FCAW in the 1G position for the OBG segment 11BW, weld No.OBW11-027.The welder is identified as #049220. ZPMC QC is identified as Mr. Zho Zhong Hai. The welding variables recorded by QC appear to comply with WPS-B-T-2231-Tc-U4b-F2.

FCAW in the 2G position for the OBG segment 11EW light bracket, weld No.LB3-004-044.The welder is identified as #040609. ZPMC QC is identified as Mr. Zho Zhong Hai. The welding variables recorded by QC appear to comply with WPS-B-T-2332-Tc-P4-F-1.

FCAW in the 2G position for the OBG segment 11AW light bracket, weld No.LB3-003-044.The welder is identified as #053486. ZPMC QC is identified as Mr. Zho Zhong Hai. The welding variables recorded by QC appear to comply with WPS-B-T-2332-Tc-P4-F-1.

SMAW in the 4G position for the OBG segment 11DW to 11EW, weld No.OBW11C-007.The welder is identified as #046709. ZPMC QC is identified as Mr. Zhou Peng. The welding variables recorded by QC appear to comply with WPS-B-P-2214-B-U2-FCM-1.

SMAW in the 3G position for the OBG segment 11DE to 11EE, weld No.OBE11A-006.The welder is identified as #053871. ZPMC QC is identified as Mr. Shi Lei. The welding variables recorded by QC appear to comply with WPS-B-P-2213-B-U2-FCM-1.
